OLD JAMESTOWN BRIDGE SITE

North Kingstown State Route 138

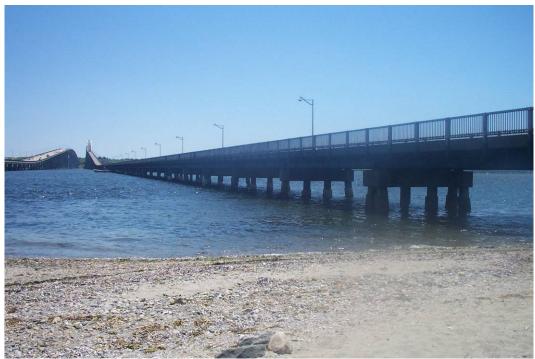
Photo 1. Old Jamestown Bridge trestle looking east from the North Kingstown shoreline.

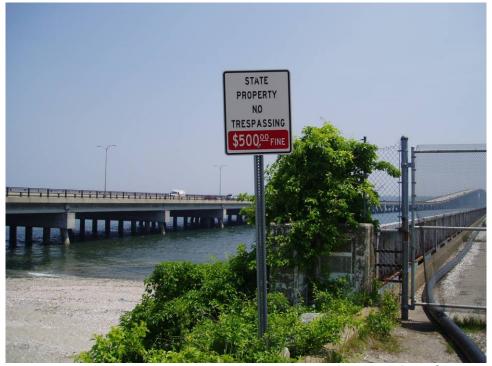
Photo 2. "No Trespassing" sign at the west abutment of the Old Jamestown Bridge (photo taken prior to demolition contract).

This Old Jamestown Bridge Site differs largely from other alternative access sites in that fishing is currently prohibited from the primary shoreline feature. For a period following the opening of the Jamestown-Verrazano Bridge, the old bridge remained accessible (but unsanctioned) for recreational fishing. During this time the site was neither maintained nor monitored, and its use was marred by littering, vandalism, and concerns over safety. These issues ultimately led to the bridge being gated-off and permanently closed to public access in the mid-1990s (see Photo 2).

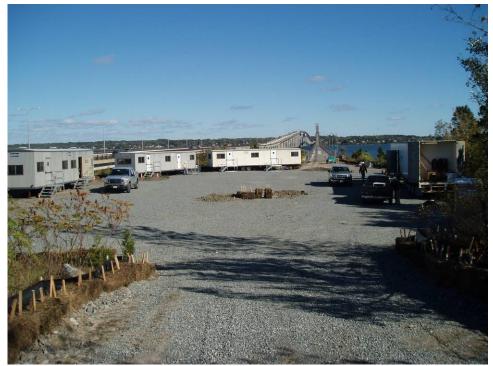
Photo 4. Demolition project field offices and work area at the Old Jamestown Bridge Site.

Land Location. (also see Section 2 of Volume I: Evaluation of the Old Jamestown Bridge Site) Located along the corridor of State Route 138 in North Kingstown, the Old Jamestown Bridge Site consists of the state-owned parcel at the North Kingstown landing of the Old Jamestown Bridge, as well as two partially constructed ramps which provide access to the site (via Route 138 Eastbound) and egress from the site (via Route 138 Westbound). The parcel is currently being utilized as a landside work area (field offices, equipment, storage) in the contract to remove the easterly three-fourths of the Old Jamestown Bridge (see Photos 4, 5).

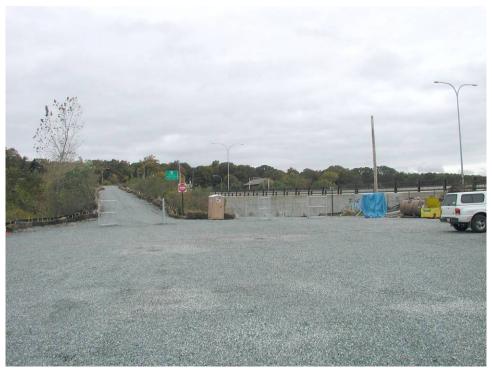
Photo 5. Construction access (left) and egress (right) ramps for the demolition contract.

consist of (a) an access ramp to the site from Route 138 Eastbound and (b) an egress ramp which underpasses the freeway to Route 138 Westbound. Both of these ramps are currently used for construction access in the RIDOT project to remove the Old Jamestown Bridge (see Photos 5, 6).

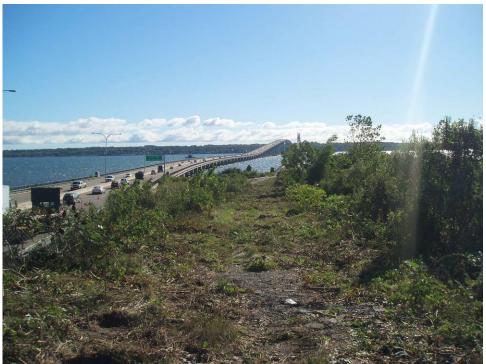
Photo 6. Looking east to the Old Jamestown Bridge Site from the access ramp (clearing for demolition project).

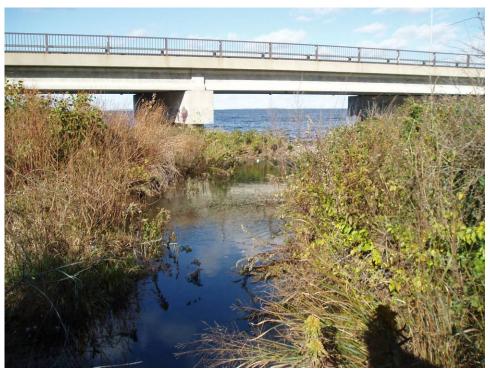
Photo 7. Brackish tidal inlet located between the Jamestown-Verrazano and Old Jamestown Bridges.

Environmental Constraints and Permitting. The West Passage waters in the vicinity of the Old Jamestown Bridge Site are designated as Type 2 (Low-Intensity Use) by the CRMC. Consisting of a sandy beach with accumulated shells, the coastal feature along this shoreline also includes a brackish tidal inlet located between the abutments of the Jamestown-Verrazano and Old Jamestown Bridges (see Photo 7). This inlet receives discharges from freshwater wetlands directly south/southwest of the landside parcel and immediately north of Route 138 (see Volume I: Evaluation of the Old Jamestown Bridge Site, Figures 10 and 11). No eelgrass is documented in the vicinity of the site.
